Date: 3/05/05

Ref: 192/MKT/E/61

SUBJECT **Best 2000 Pipette Module
Preventive Maintenance**

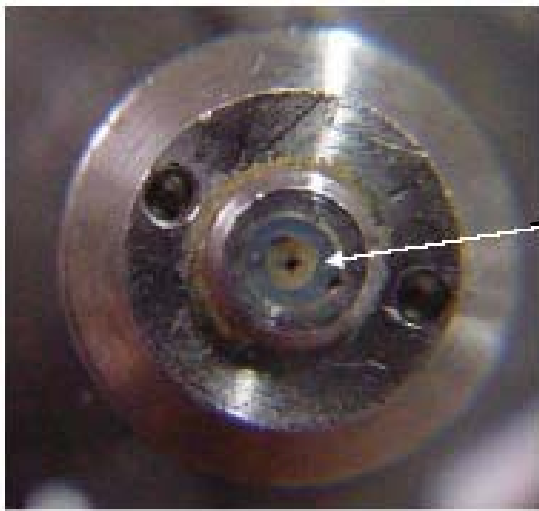
Best 2000 Pipette “ESP/Blockage” errors can be caused by a restriction in the spigot PTFE tubing due to a gradual build-up of fluid (believed to be a foamy reagent, reaching the bottom of the spigot as a bubble during high-volume aspiration), which dries in layers on the inside of the tube. Typically the build-up is confined to the tip only, not further up the tubing. Previously, this blockage would warrant the replacement of the pipette module, however a new technique has been developed for removing the blockage without removing the pipette from the Best 2000.

Blockage in the PTFE tubing

Figure 1 – Bottom view of the pipette spigot showing typical blockage in the PTFE tubing.

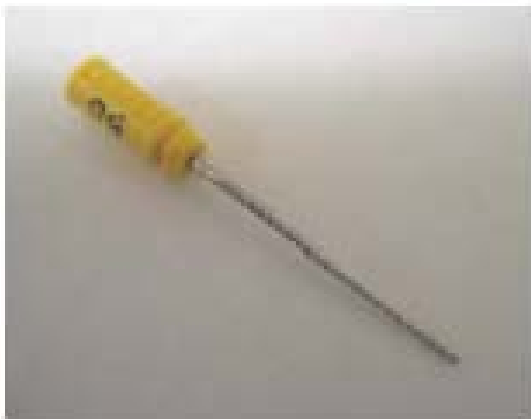
Figure 2 -Root canal reamer.

A root-canal reamer (Figure 2), which is a tapered cutting tool with coarse, helical flutes, can be used to remove the blockage. When attempting to remove blockage from the pipette by any means, the primary concern is to prevent the blockage from being pushed further up the tubing. Due to its shape, when the root-canal reamer is rotated (clockwise) while being gradually inserted into the tubing, the debris is pulled out (Figure 3). When using the tool however, care must be taken not to cut the inside wall of the tubing. This is a matter of “feel”, but can also be regulated by the depth of insertion of the tool. Approximately 1 cm inside the tubing, the gland-nut restricts the inside diameter, so care must be taken not to cut the tubing at this point.

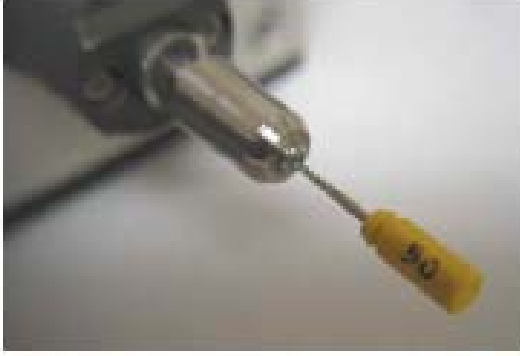
Figure 3 -Root canal reamer inserted into the pipette spigot.

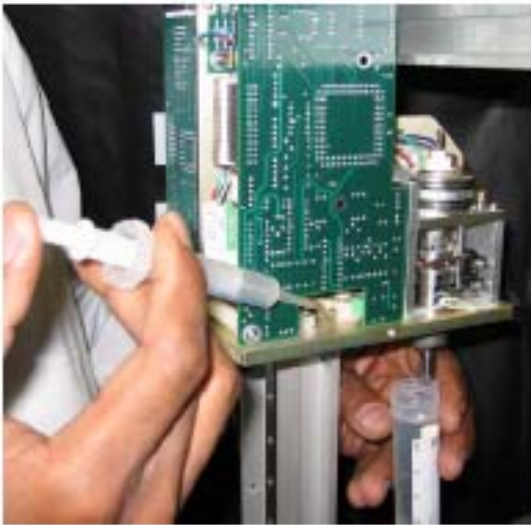
Figure 4 - Injecting alcohol into the tubing from the sensor end.

Once the offending material has been removed, the line is flushed using alcohol, injected through the tubing from the sensor-end (Figure 4). Ensure all alcohol is expelled and the tubing dry before reconnecting the tubing to the sensor and self-testing the system. When reconnecting the tubing care must be taken ensure it is returned to the same location on the sensor end.
